Corrosion

Official Publication
NATIONAL ASSOCIATION OF CORROSION ENGINEERS

JUNE 1952

Page
The Editorial Review Committee By George Diehlman.....	193
The Inter Society Corrosion Committee By-Laws.....	194
Gasoline Resistant Tank Coatings By W. W. Cranmer.....	195
Isolation of Trolley Bus Negative Return to Prevent Stray Current Corrosion By L. Horvath, H. E. Nerhood, S. M. Seidman and R. H. Travers.....	205
Interconnection of Pipe Lines Having Various Coatings By David Hendrickson.....	212
A Case History Involving Intergranular Failure of Stainless Steel Heater Tubes By G. A. Works.....	217
Discussion—The Mechanism of Knife-Line Attack in Welded Type 347 Stainless Steel By J. J. Heger; Reply by M. L. Holzworth, F. H. Beck and M. G. Fontana.....	222
Errata.....	223

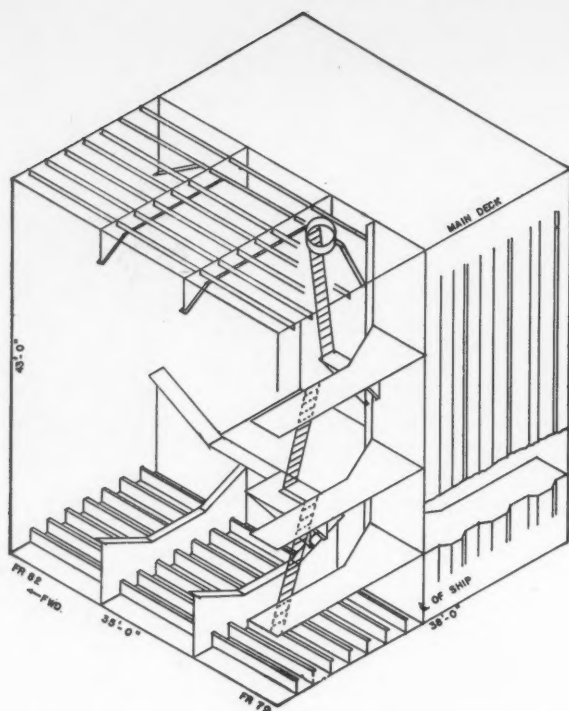
Figure 1—Pictorial isometric sketch, main gasoline cargo tank.

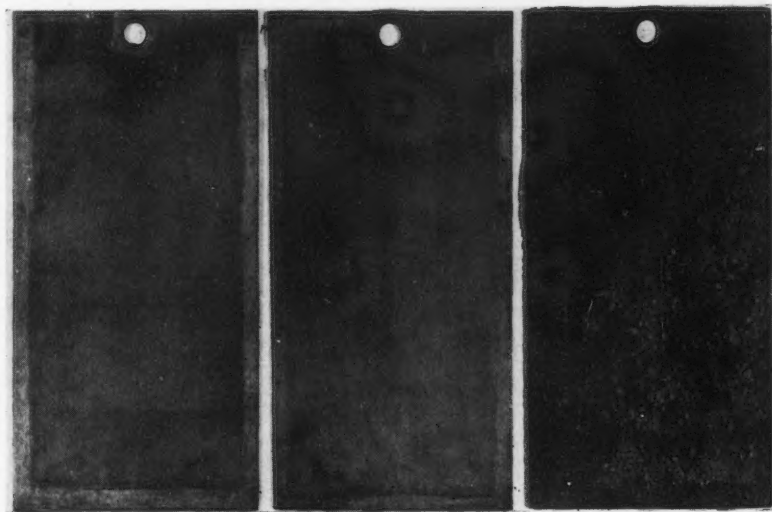
130 degrees F 155 degrees F 175 degrees F
Figure 3—Effect of temperature failure at 175 degrees F.

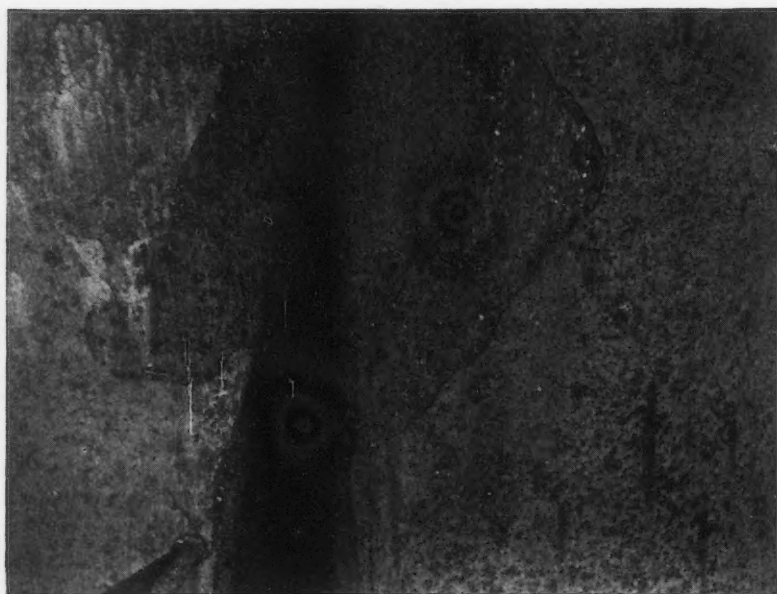
Figure 5—Typical scaly corrosion in gasoline cargo tank.

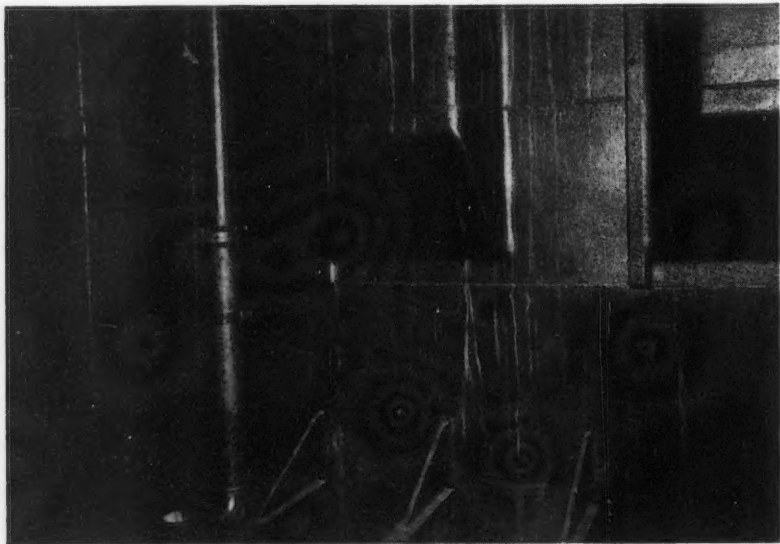
Figure 11—Area coated with Saran-type material.

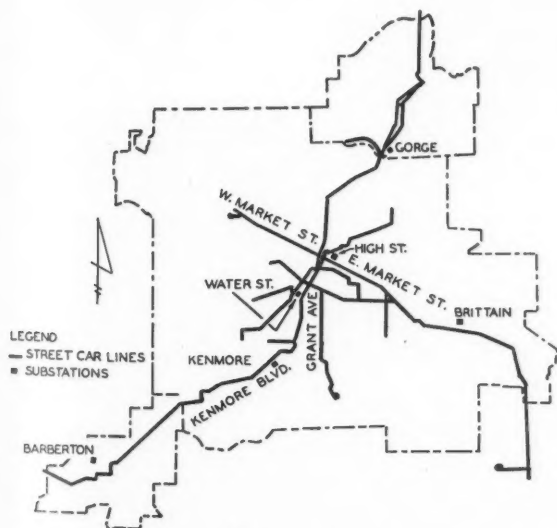
Figure 1—Akron and suburbs street railway systems of 1921.

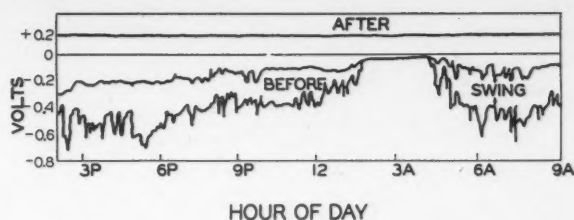
Figure 6—Cable-to-earth potential, corner Main and Exchange, before and after isolation.

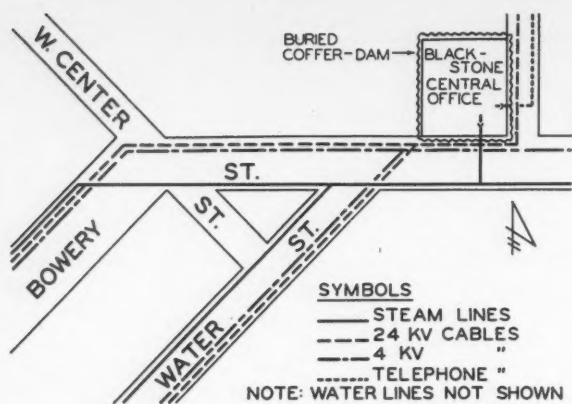
Figure 9—Blackstone Central Office and vicinity.

The Blackstone case had to do with the power cable failures in the vicinity of the Blackstone central office, the only telephone central office in the downtown section. (See Figure 9.) Tests made in 1948 and 1949 revealed local stray current, some of which was identified as caused by grounded battery supply to private telephone switchboards. This source was eliminated by the telephone company. Retest showed that part of the area involved was improved but a duct survey disclosed that there was an anodic area close to the Blackstone Central Office. This effect was traced to an unsuspected cofferdam surrounding the Blackstone building below the ground level and iso-

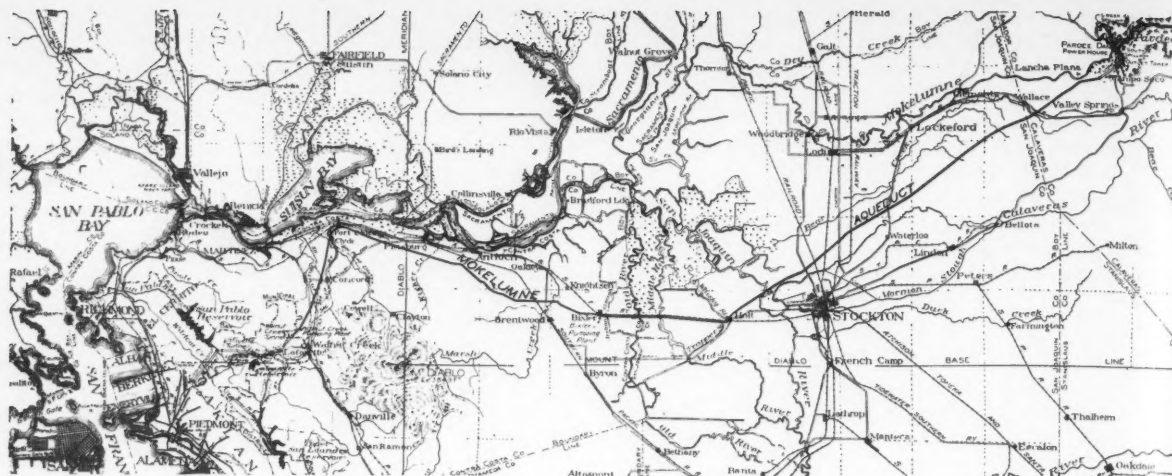
Figure 1—Routes of aqueducts serving San Francisco Bay area.

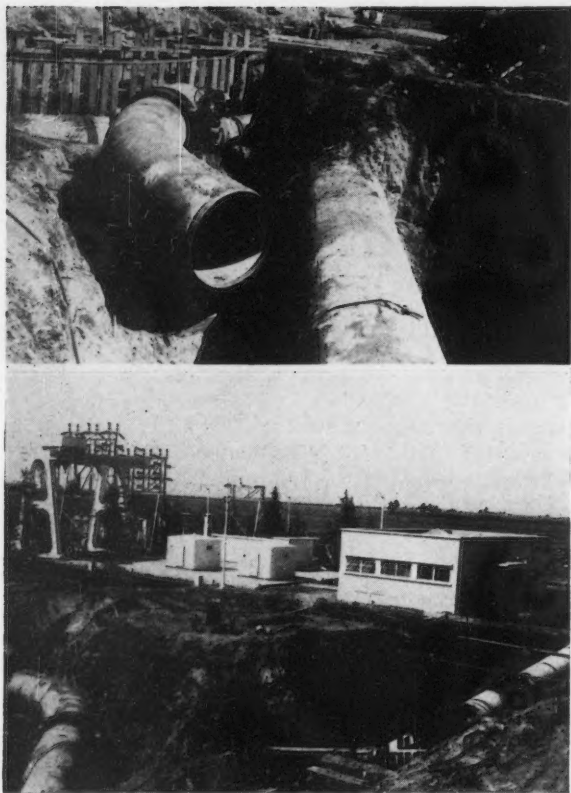
Figure 3—Installation of cross connections of the Mokelumne Aqueducts at Bixler.

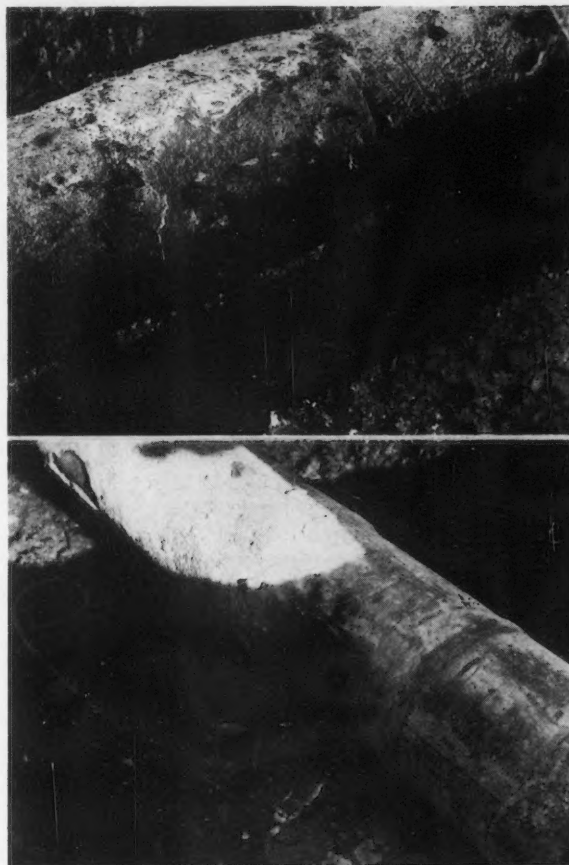
Figure 4—Disintegration of concrete coating on the Crockett pipe line.

This compound galvanic action does not always confine the corrosion to pits. In one case an area of ten square inches became so thin that it burst under a pressure of approximately 120 psi. In this case the aqueduct had to be shut down and drained before it could be repaired. Figure 4 shows the effect of this type of corrosion.

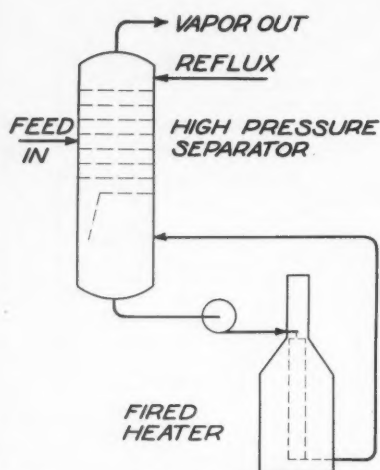
Figure 1—Circulating flow through the fired heater and high pressure separator.

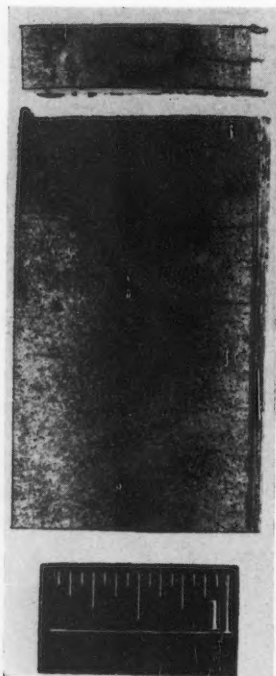
Figure 3—Section of failed tube showing OD cracks penetrating tube wall.

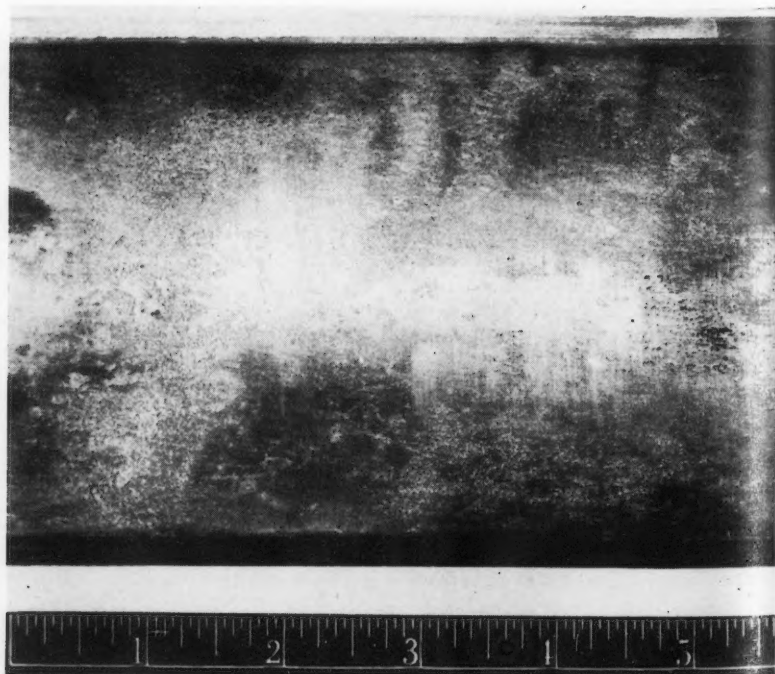
Figure 4—General pitting on pickled ID surface.

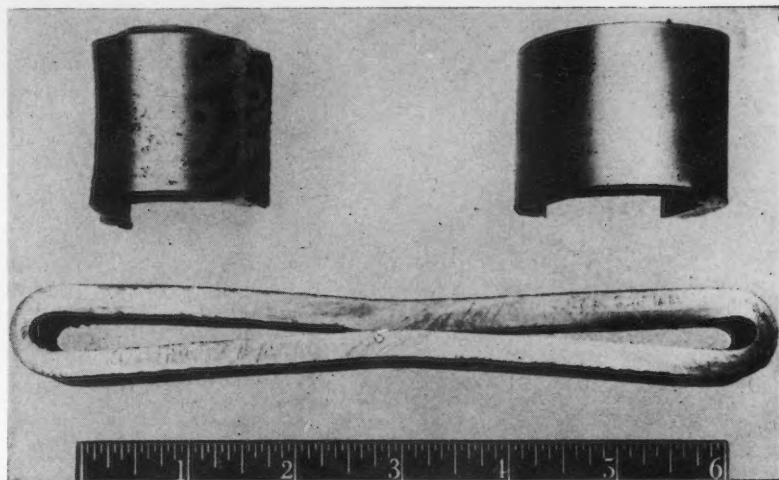
Figure 5—Bending and flattening tests on section of failed tube.

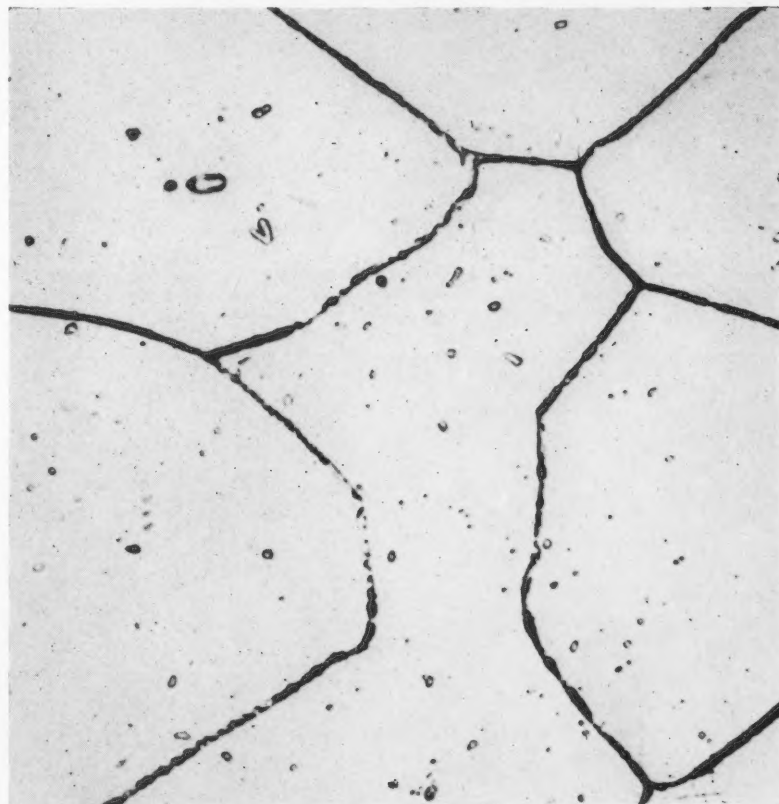
Figure 6—Showing carbides present in chain-like continuity at the grain boundaries. Magnification: 1000x Etch: 10% oxalic acid.

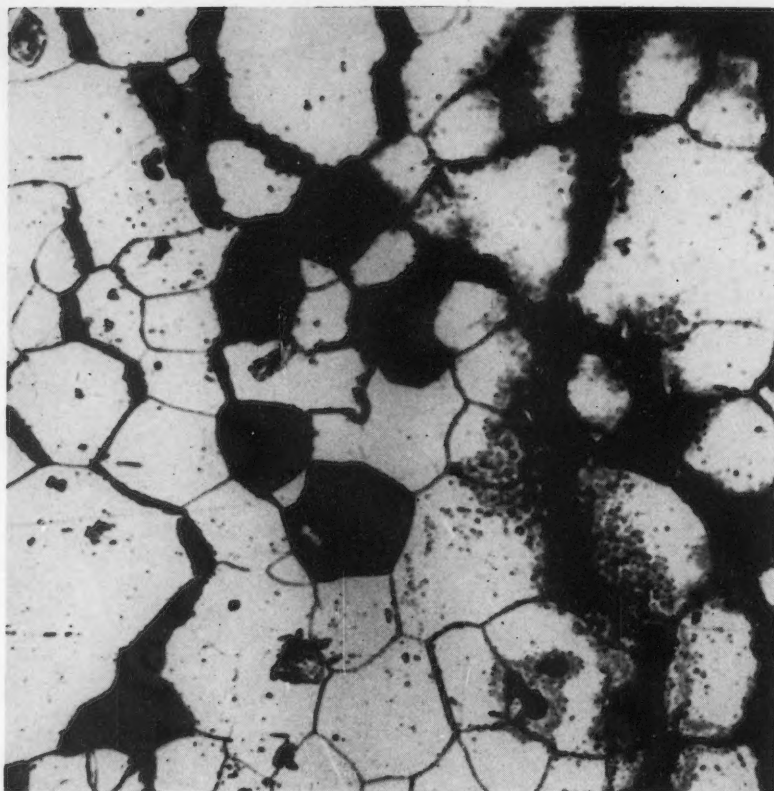
Figure 7—Showing intergranular corrosion cracks at and immediately adjacent to a circumferential fracture visually apparent on the tube surface. Note: Some whole grains have dropped out of this plane surface. Magnification: 100x Etch: 10% oxalic acid.

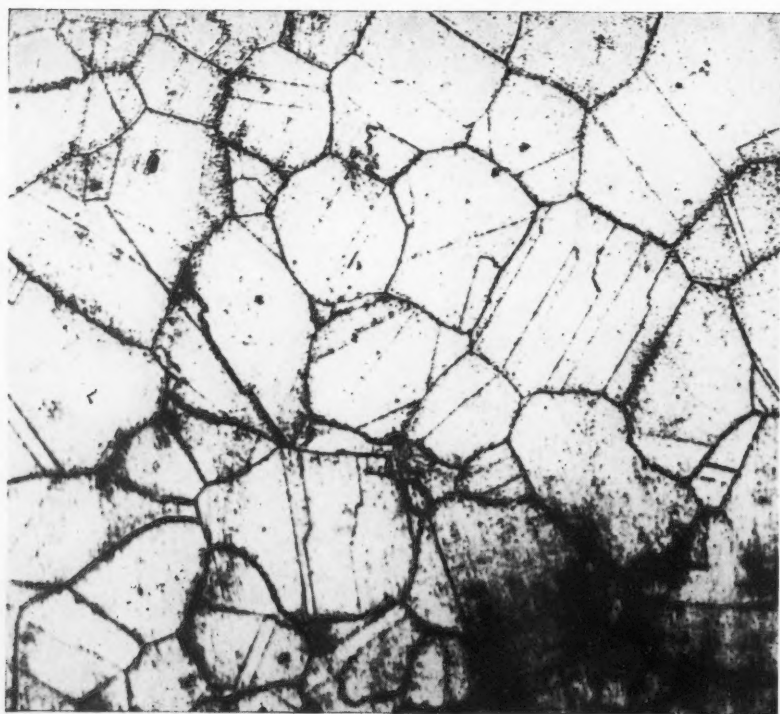
Figure 9—Tube specimen after 1600 degrees F heat treatment. Magnification: 100x Etch: 10% oxalic acid.

1600 degrees F. for an extended period. This operation is carried out now during manufacture of austenitic stainless steel tubes intended for corrosive service at elevated temperatures. However, this procedure was not followed at the time the tubes in question were made. The purpose of this treatment is to precipitate carbides at the grain boundaries and then cause the carbides to agglomerate or nodulize thus breaking up the continuity of the network. This treat-

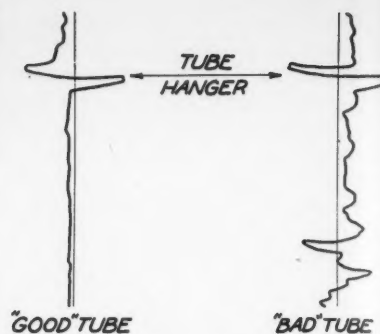
Figure 8—Probolog charts.

A chart was run on all tubes and the records indicated that two rough classifications might be made; one in which relatively smooth charts were obtained pointing to minor defects, the other in which wide deflections were recorded suggesting cracks or potential cracking. Runs for standardization on a new and a cracked tube aided in the separation. Figure 8 shows typical charts obtained.

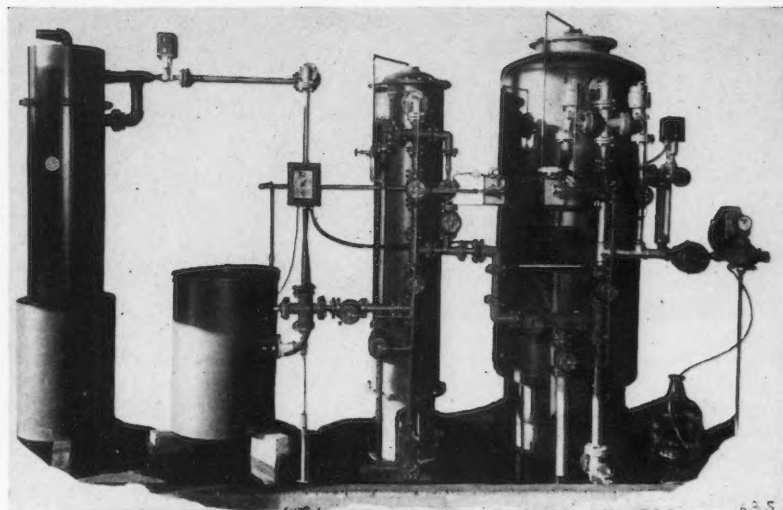
Figure 1—Completely automatic de-ionizer piped throughout with Saran-lined steel. Tanks and valves are rubber lined.

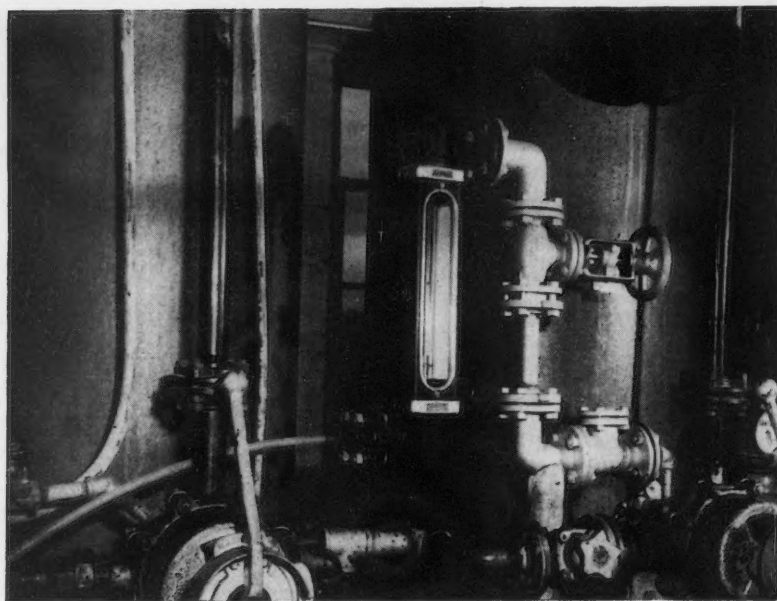
Figure 2—De-ionizer with Saran piping and corrosion-proof acid handling system. Acid valves are Alloy 20. Piping is Saran-lined steel.

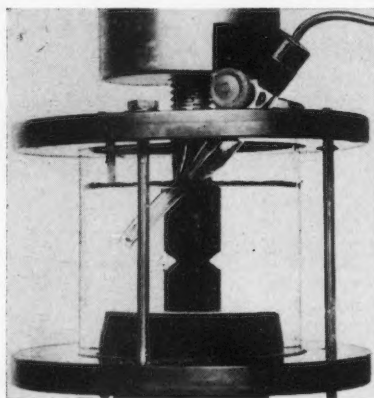
Figure 1—In a recent study of stress corrosion by the National Bureau of Standards, metal specimens were abraded in an inert (argon) atmosphere to remove the air-formed film that is ordinarily present. Using the equipment shown, the operator works through rubber gloves to abrade specimens inside the argon-filled-and-sealed enclosure. Electrochemical solution potentials of the film-free specimens are then measured without removing the specimens from the air-free enclosure. Photo 20929-649.

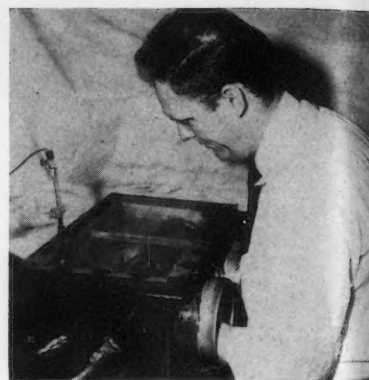
Figure 2—To measure the change of electrochemical solution potential with stress in the NBS investigation, a notched metal specimen (center) was placed in a suitable cell filled with an electrolyte (usually potassium chloride). The potential between the specimen and an immersed electrode (entering the solution at an angle) was measured as a tensile stress was applied to the specimen. The specimens were coated with non-conducting waterproof lacquer, a thin strip of which was removed at the base of the notch to expose a small maximum-stress area of metal. Photo 520200-649.

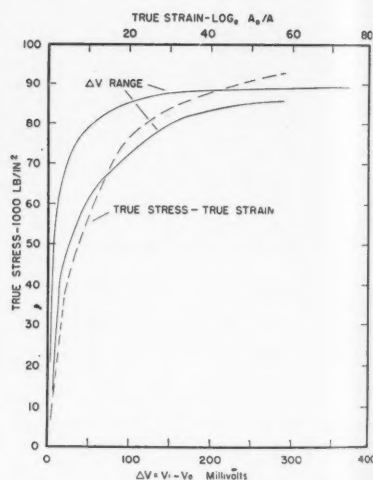
Figure 3—Change of potential with stress (solid lines) and true stress-true strain relations (dotted line) for 61% Cu, 36% Zn, 3% Pb brass, as found in the NBS stress-corrosion study. Photo 510425-649.
